**Client Name**

**Property Address:**

**Informed Decisions Certified Home Inspections LLC**

<b>Date:</b> 9/1/2010	<b>Time:</b> 09:00 AM	<b>Report ID:</b> Sample 2
<b>Property:</b> Address City FL Zip	<b>Customer:</b> Client Name	<b>Real Estate Professional:</b> Patrick Moore Remax

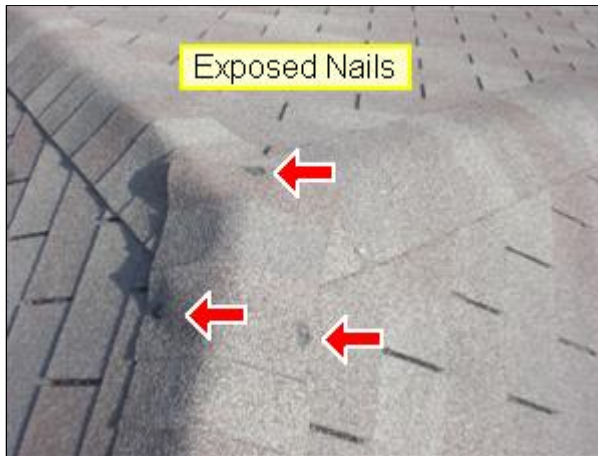
1.0

The roof covering has nail pops and exposed nail heads in various locations . These areas will need periodic maintenance. The exposed nails should be tarred to prevent corrosion and future water intrusion..

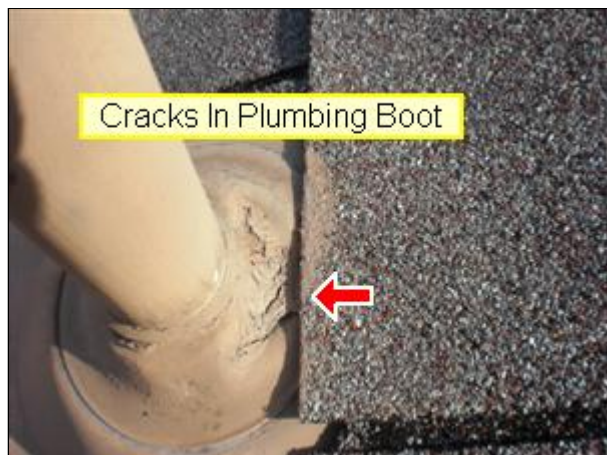
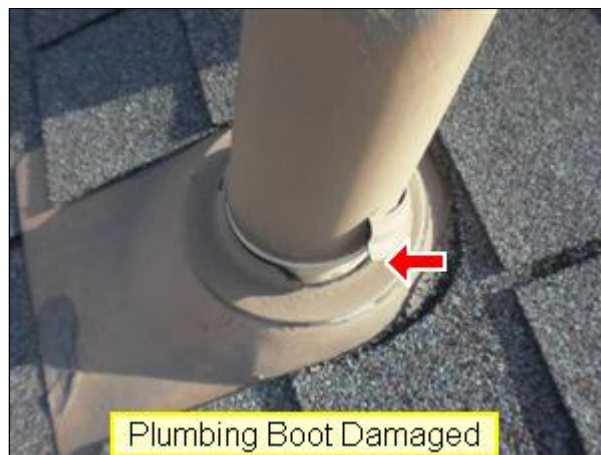
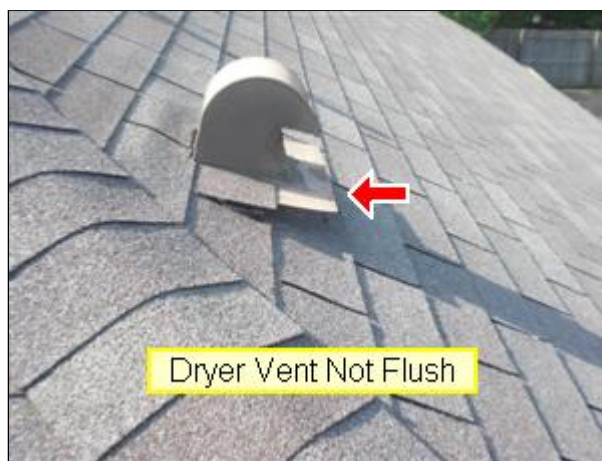
1.2

All rubber boots for the plumbing vents are cracked or deteriorated and can cause water damage. The dryer vent has lifted and is not flush with the roof surface. An appropriately licensed contractor should make repairs.

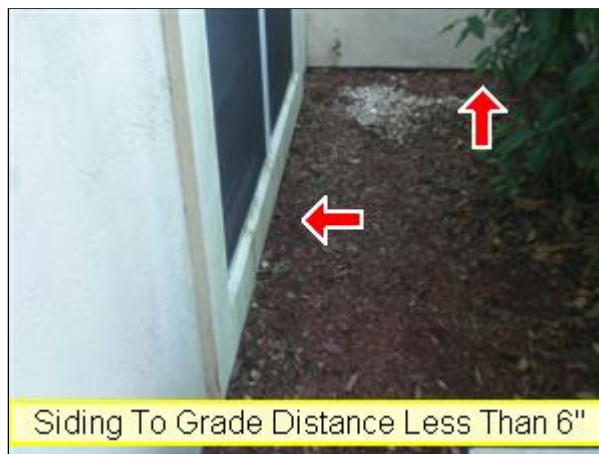
**2.0**

(1) Siding is in close proximity to the soil at the front of the home. This can allow pooled water to enter the siding during storms and also allow for insect infestation. We did not inspect behind this siding. Recommend a ground clearance of six to eight inches where possible.

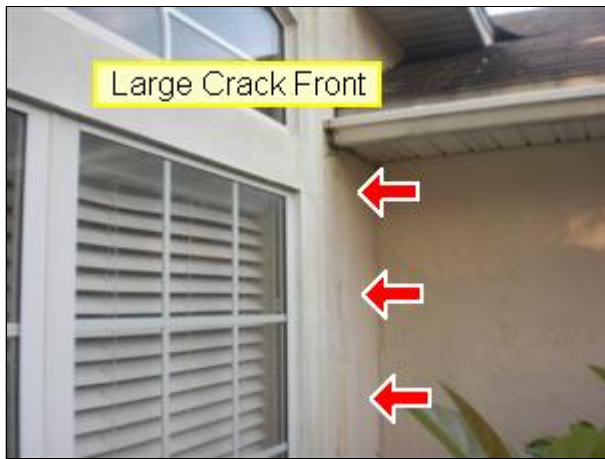
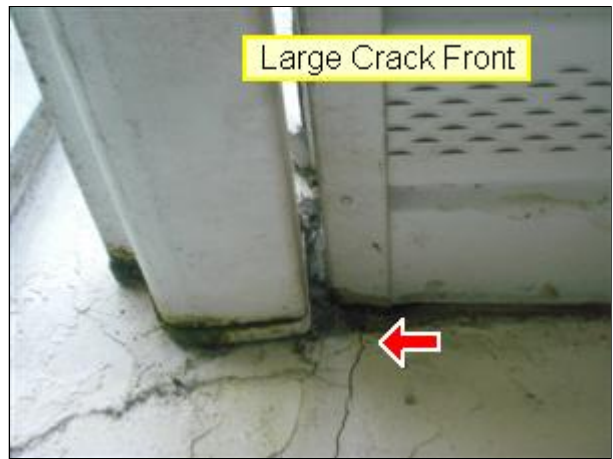
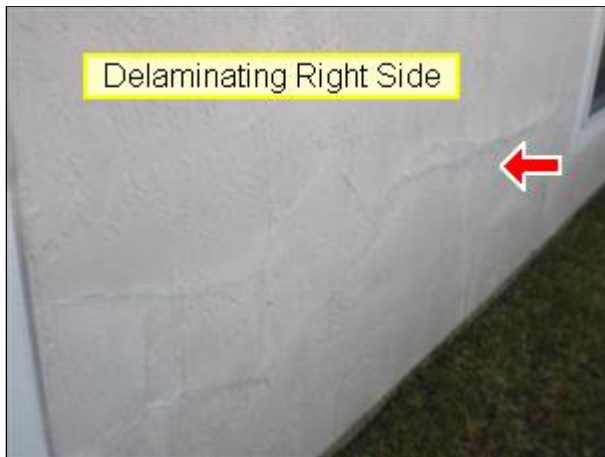
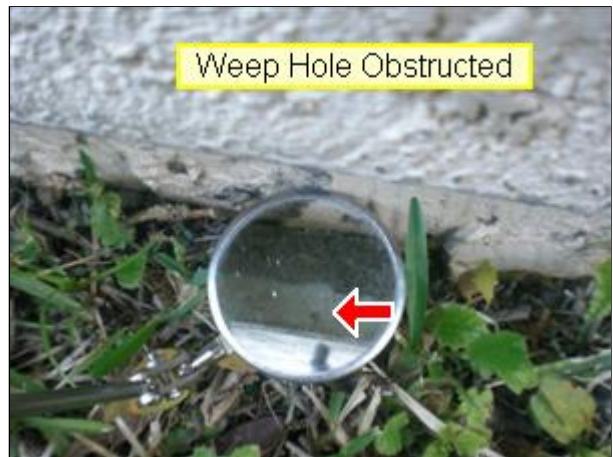
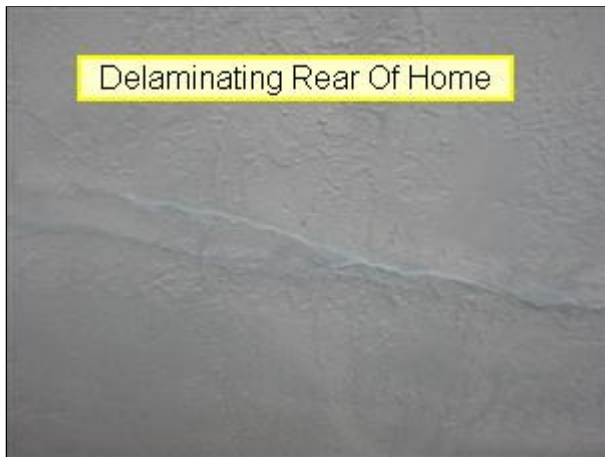
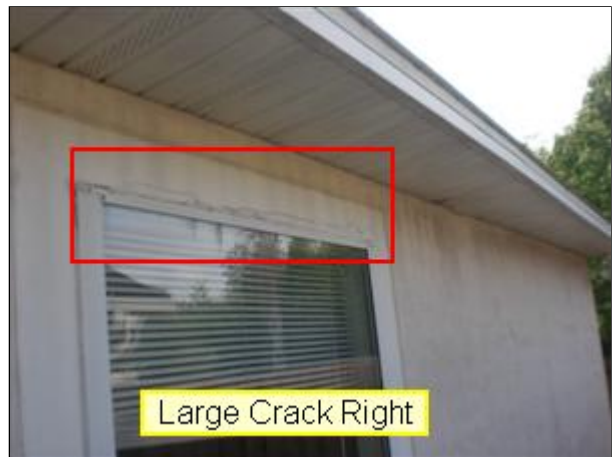
🏠 (2) The Stucco coating at the front of home , right side (facing front) and rear of home has large cracks and is delaminating. This may be caused by poor flashing installation and the weep holes being obstructed at the lower edge of the siding. Further deterioration can occur if not corrected. An appropriately licensed contractor should evaluate further and make repairs or replace as needed.

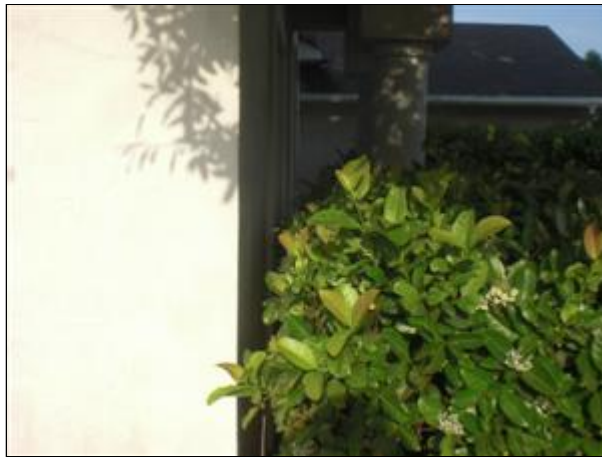
🏠 2.4

Vegetation is encroaching on the structure, and should be kept a minimum of twelve inches away for the general welfare of the walls and foundation. Vegetation in contact with the wall can trap moisture and allow for insect infestation.

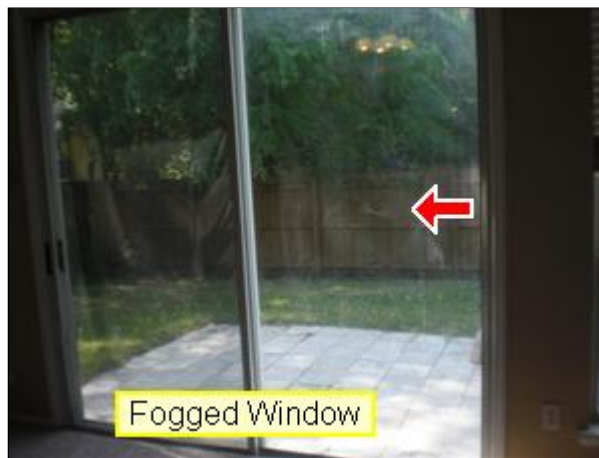
4.6

Three windows Sliding Glass door window cloudy (lost seal) at the Living Room. . An appropriately licensed professional should make repairs or replace as needed.

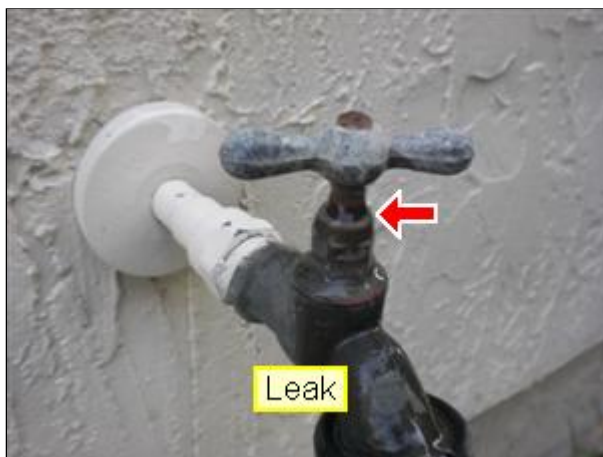
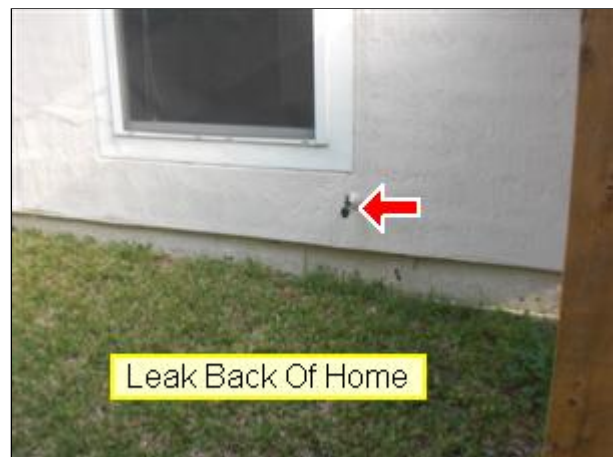
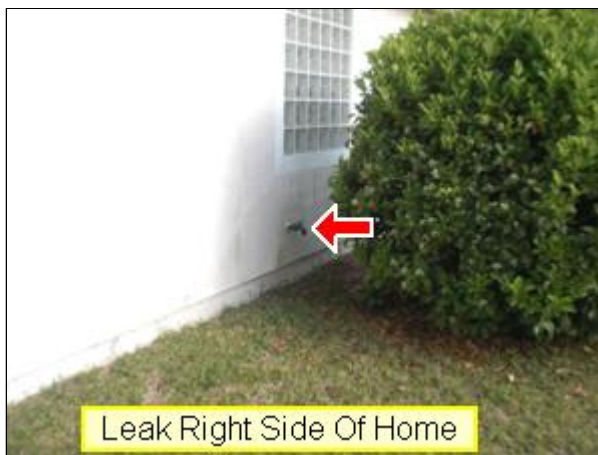
**6.1**

The hose bibs leaks at the valve stem when turned on and is located at the rear of home and left side (facing front). An appropriately licensed contractor should make repairs.

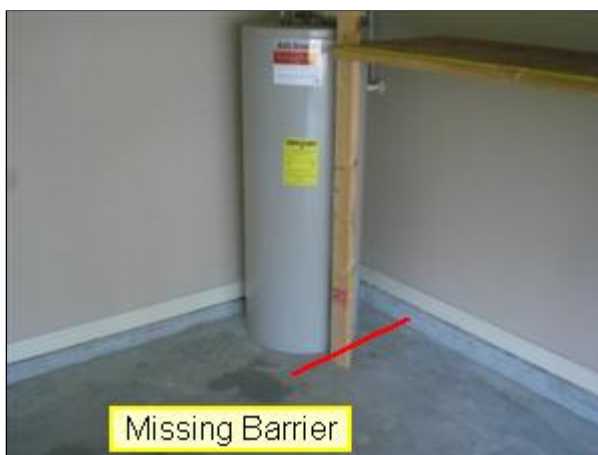
**6.2**

The water heater is located inside the garage and does not have permanent protection from vehicle impact. A barrier should be installed to protect the water heater from vehicle impact. I recommend a qualified person make repairs as required.

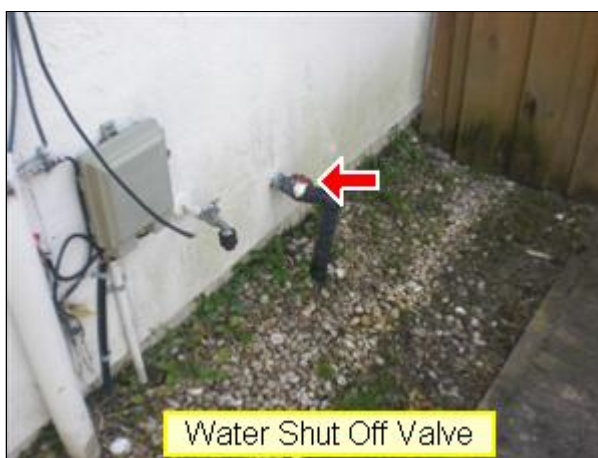
**6.3**

The main shut off is located right exterior wall of the home.

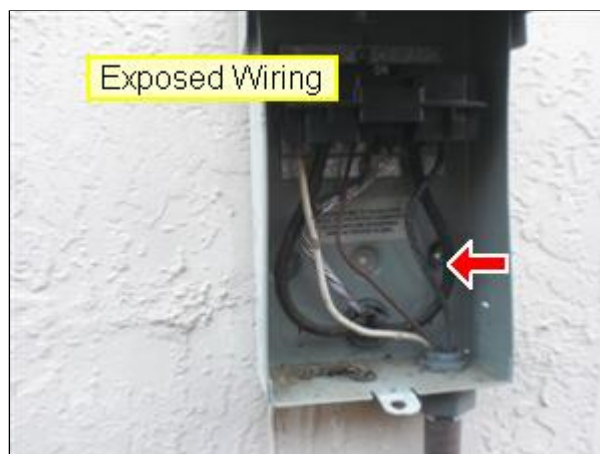
7.1

The electrical wiring is exposed at the servicemans switch for the compressor. A cover should be installed.

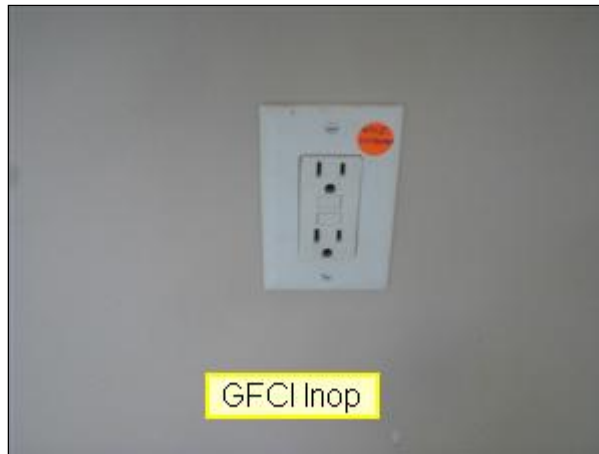
7.5

the GFCI (Ground Fault Circuit Interrupter) outlets at the garage and exterior wont "trip" when tested. Electrical issues are considered a hazard until repaired. A qualified licensed electrical contractor should perform repairs that involve wiring.

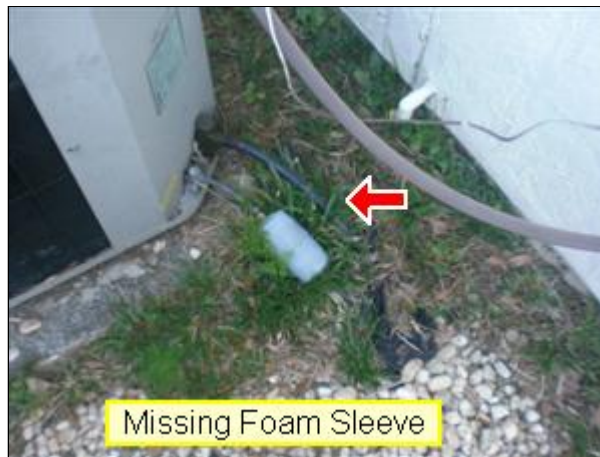
8.0

The foam sleeve on the refrigerant line is missing. Missing foam on the refrigerant line can cause energy loss and premature failure of the unit. An appropriately qualified person should make repairs.

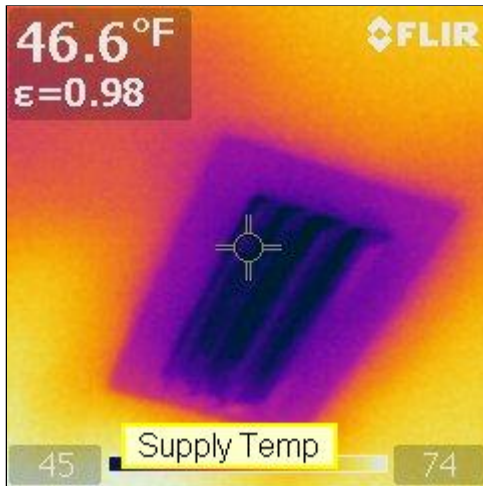
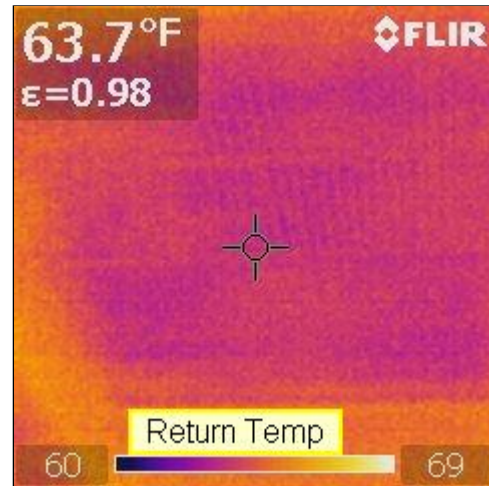
8.8

The ambient air test was performed by using thermometers on the air handler of Heat pump in cool mode to determine if the difference in temperatures of the supply and return air are between 14 degrees and 22 degrees which indicates that the unit is cooling as intended. The supply air temperature on your system read 46 degrees, and the return air temperature was 63 degrees. This indicates the range in temperature drop is normal.
