Property Address:

Informed Decisions Certified Home Inspections LLC

Date: 9/1/2010	Time: 09:00 AM	Report ID: Sample1
Property: Address City FL Zip	Customer: Client Name	Real Estate Professional: Bob Woods ReMax

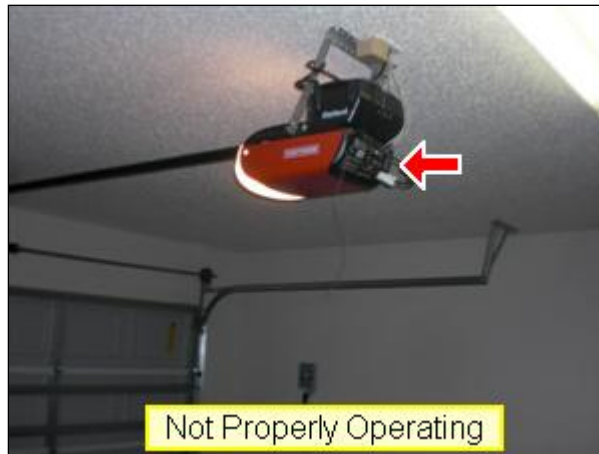
3.5

The automatic opener for the garage door at the front of the home would not close unless the button remained depressed. This is not functioning properly. A qualified person should inspect and repair as needed.

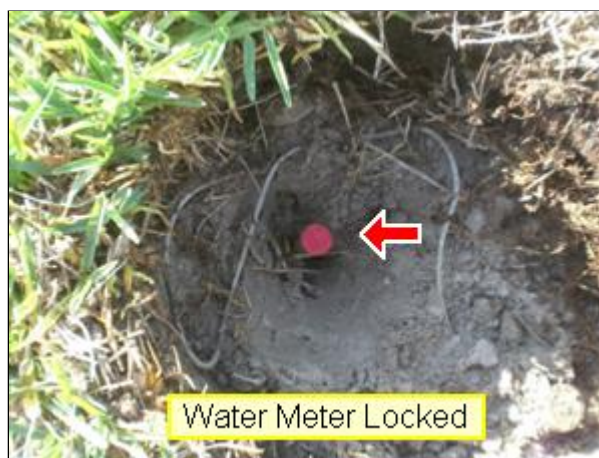
6.1

At the date of the inspection the water was turned off at the meter and was locked. At the time of the follow up inspection on 4/24/10 the power was off. We were not able to perform a functional check of the water heater or the dishwasher.

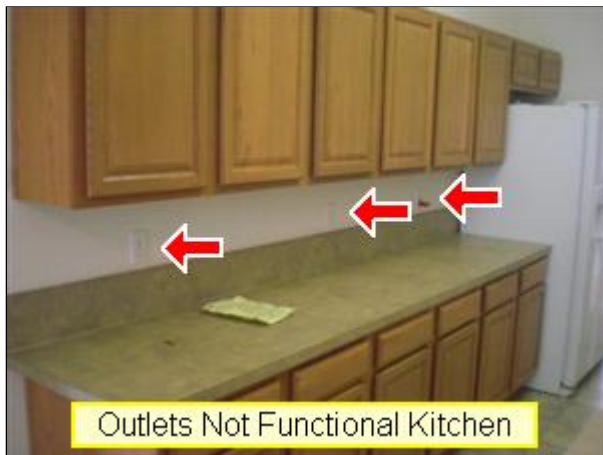
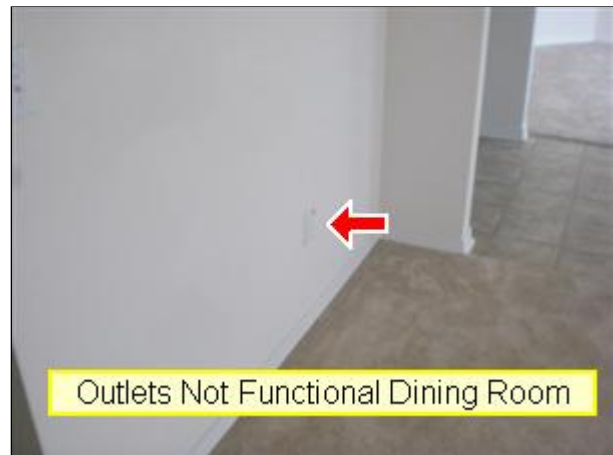
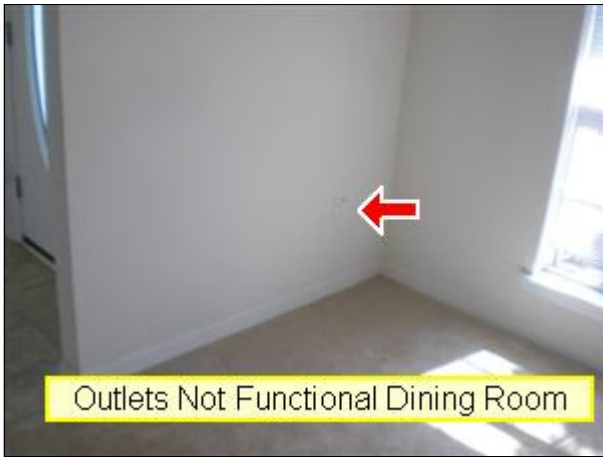
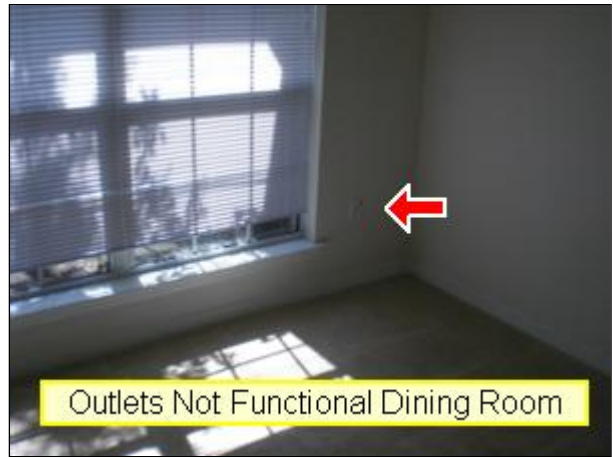
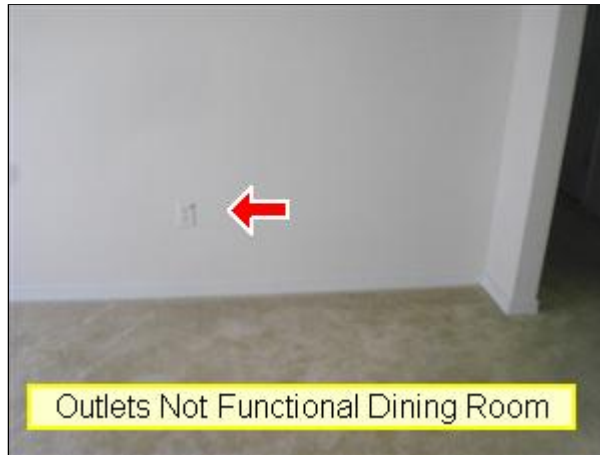
7.3

None of the outlets along the right counter in the kitchen or the dining room were working at the time of the inspection. The circuit breakers were in the on positions. An appropriately licensed contractor should evaluate and make necessary repairs.

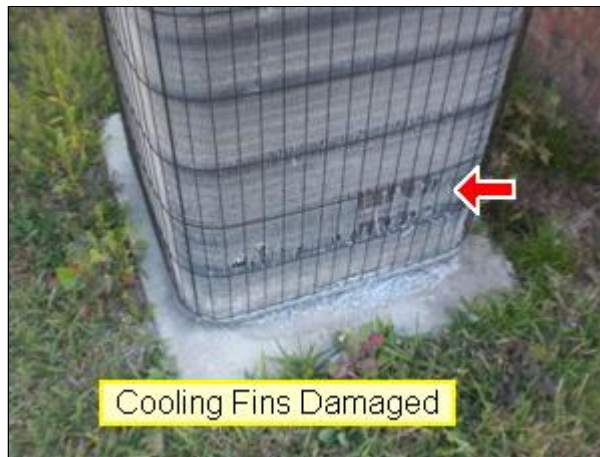
8.8

(1) The cooling fins on compressor are damaged. This can cause damage to the unit or shorten its life span. A qualified HVAC person should inspect further and repair or replace as needed.

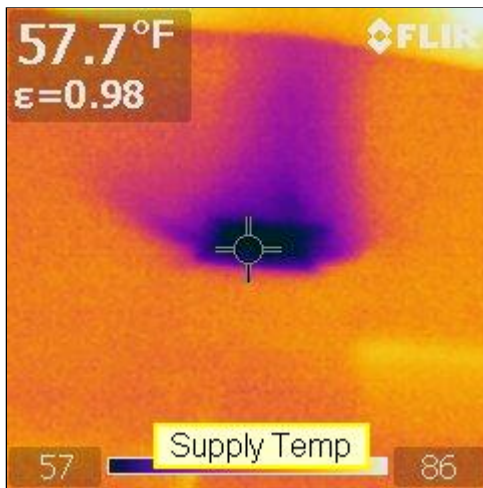
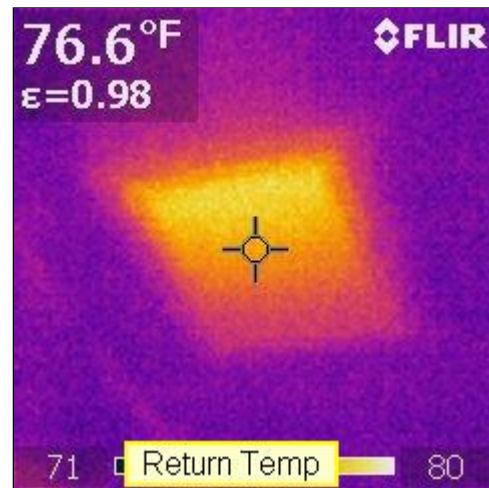
(2) The ambient air test was performed by using thermometers on the air handler of Heat pump in cool mode to determine if the difference in temperatures of the supply and return air are between 14 degrees and 22 degrees which indicates that the unit is cooling as intended. The supply air temperature on your system read 57 degrees, and the return air temperature was 76 degrees. This indicates the range in temperature drop is normal.

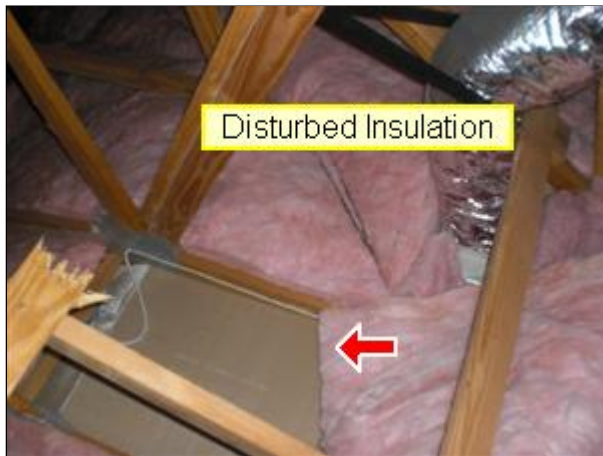
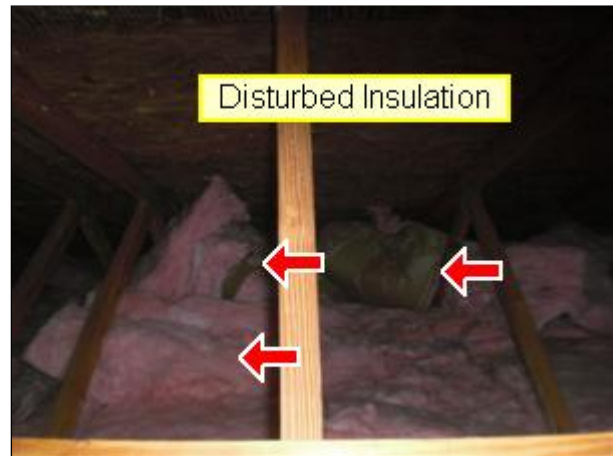
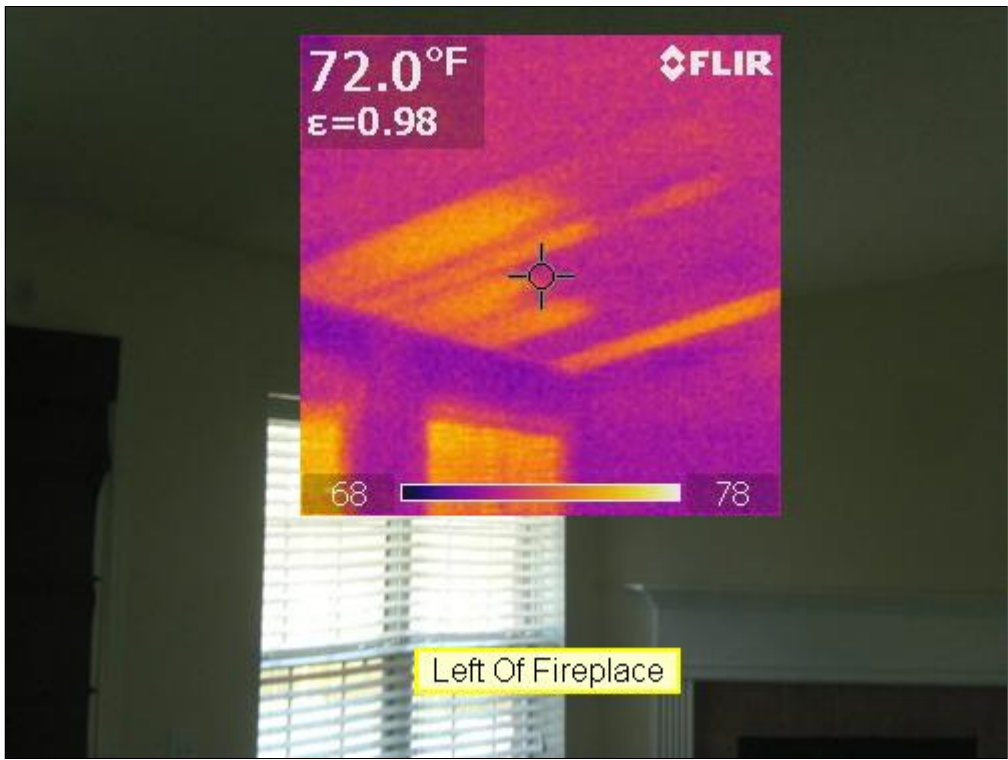
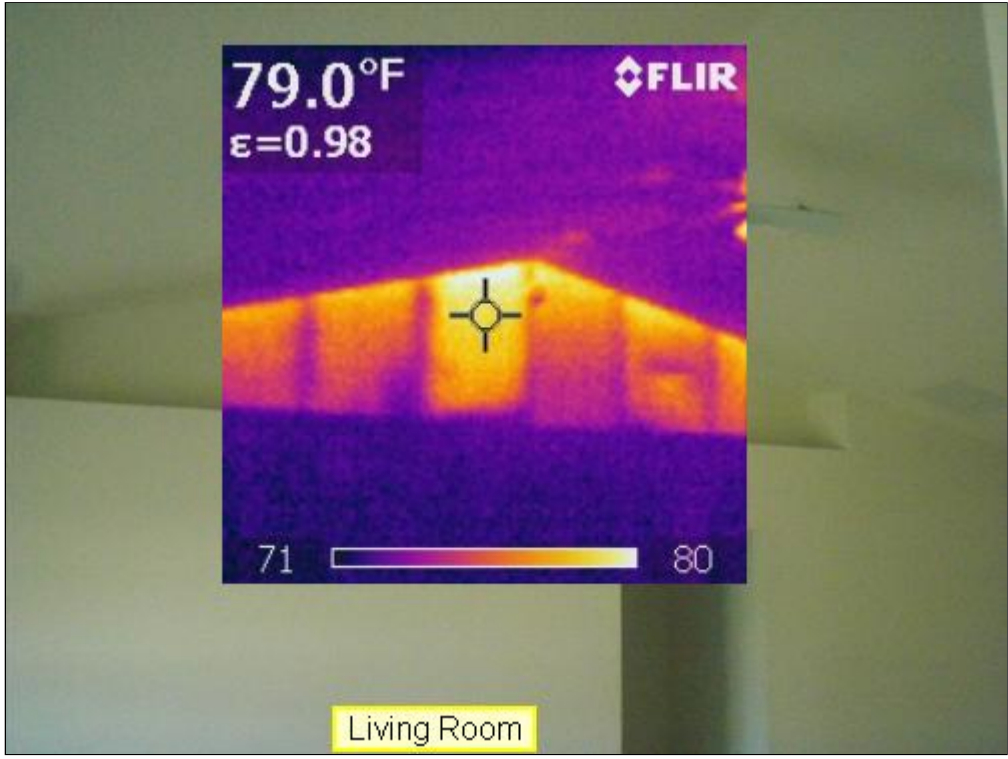
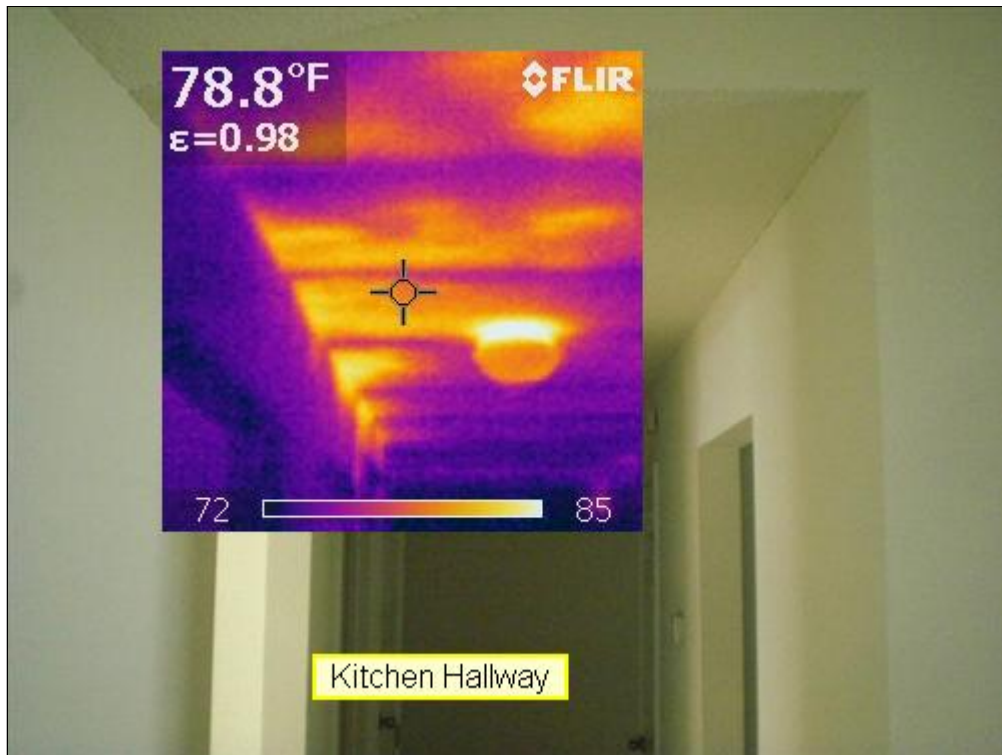
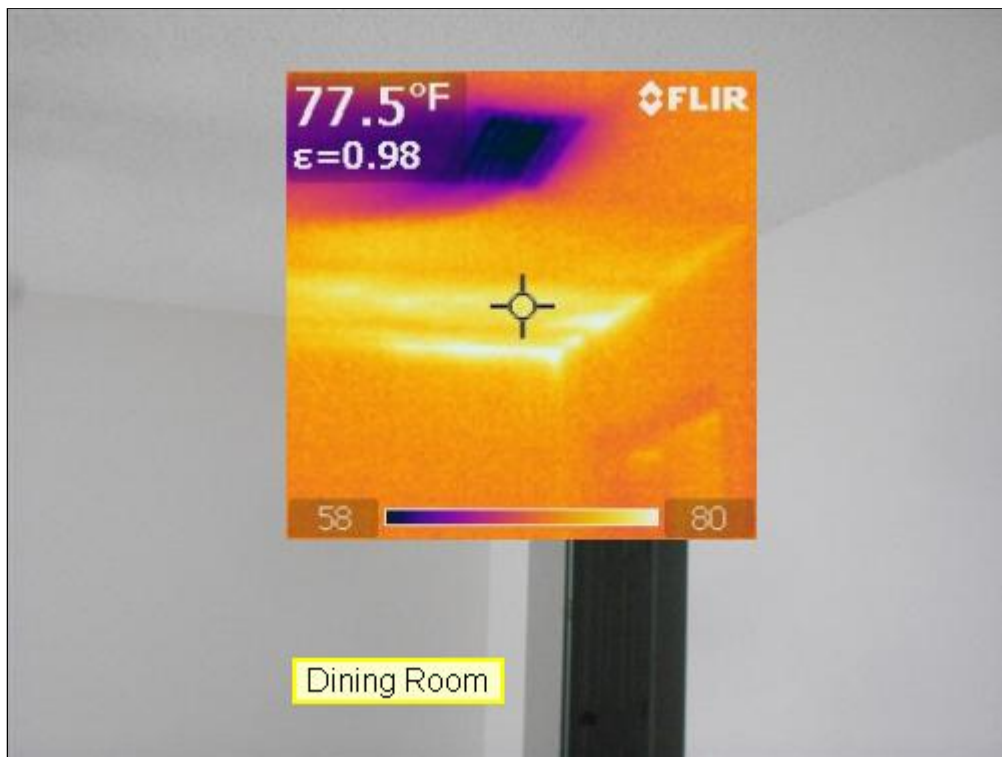
9.0

Insulation is has been disturbed and is lacking above and to the left of the fireplace, the living room, the hallway by the kitchen and the dining room. Heat loss can occur more on this home than one that is properly insulated. An appropriately qualified person should make repairs.
