September 01, 2009

**Property Address:
Address
Jacksonville FL Zip**

Informed Decisions Certified Home Inspections LLC

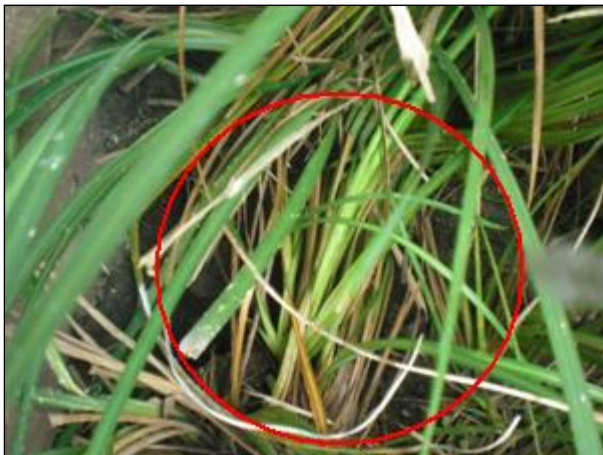
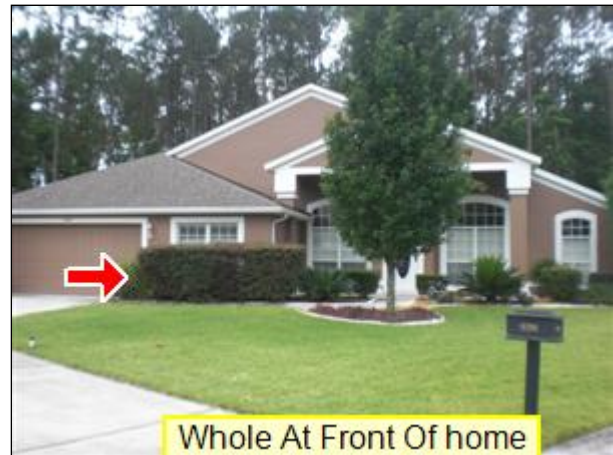
2.4

(1) There is a large whole that was dug at the front of the home to the left of the garage. A qualified person should remove the vermin and the whole should be filled.

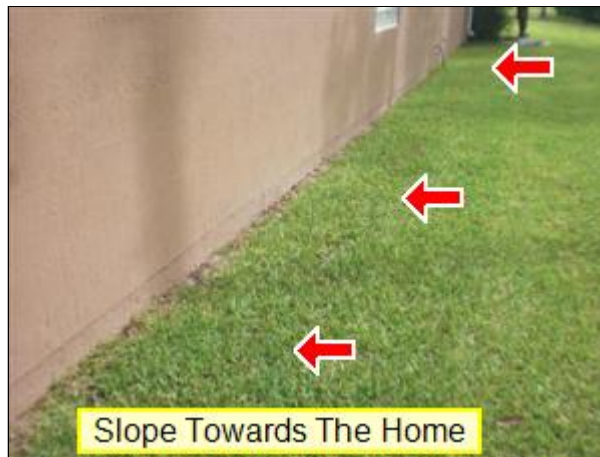
🏠 (2) There is a negative slope at the left side (facing front) and can cause or contribute to water intrusion or deterioration. I recommend correcting landscape to drain water away from home.

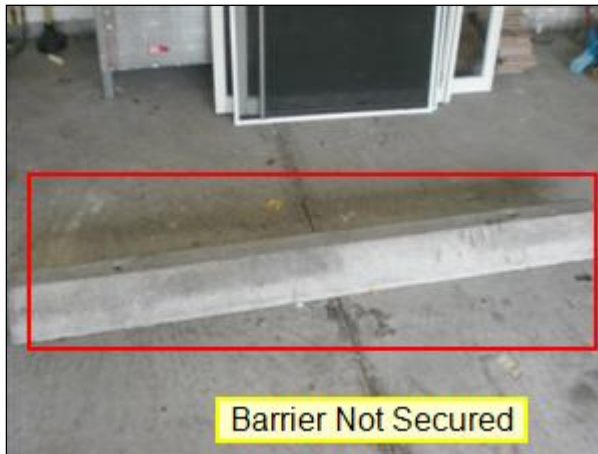
3.2

The barrier in the garage to protect the mechanical equipment is not secured to the floor. This barrier is meant to protect the mechanical equipment from being damaged by vehicles being parked in the garage. A qualified person should make repairs.

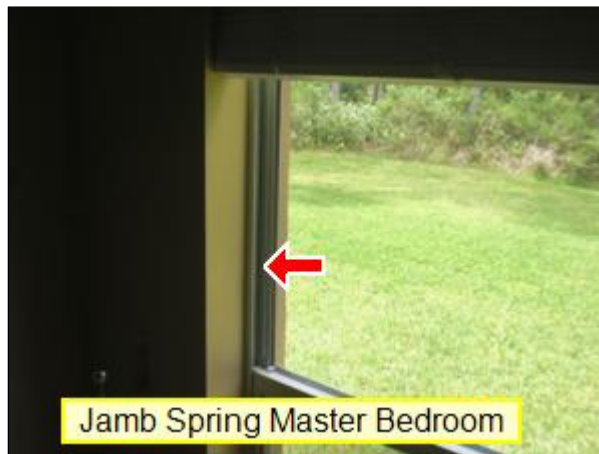
**4.6**

One window the jamb spring is weak or no longer works properly at the Master Bedroom. . A qualified person should repair or replace as needed.

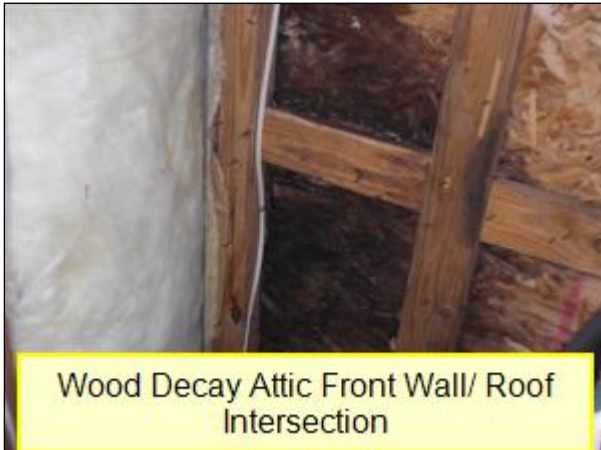
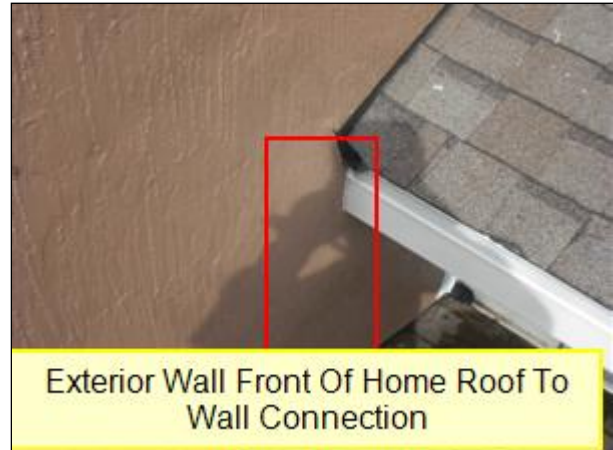
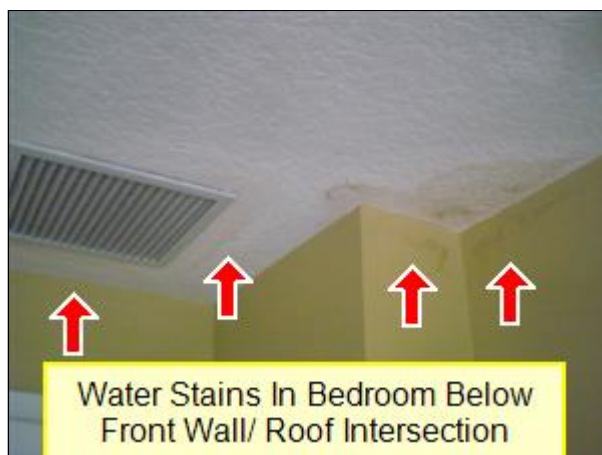
5.1

The OSB panels on the wall at the front of the home inside the attic where the roof meets the wall has water entering behind covering and needs to be corrected. The flashing at this area is suspected to be the cause of The repair work will likely involve the removal of covering in order to repair the framing. The extent of damage cannot be realized until the covering is removed. A qualified person should repair or replace as needed.

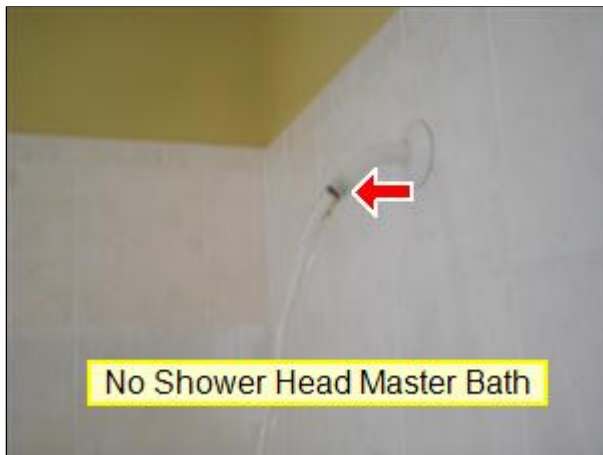
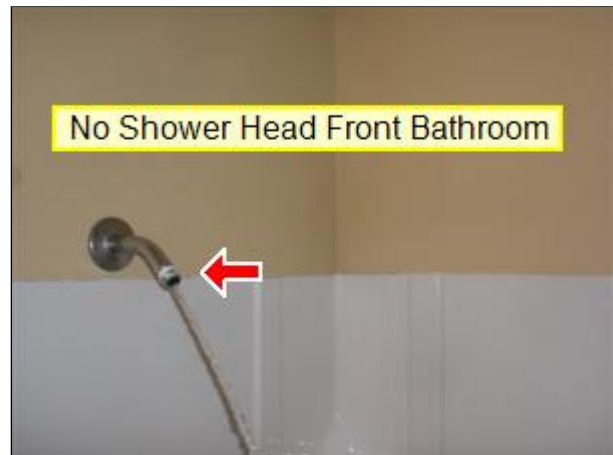
6.1

The shower heads at the bathroom at the front of the home and the master bathroom are missing. A qualified person should replace the shower heads.

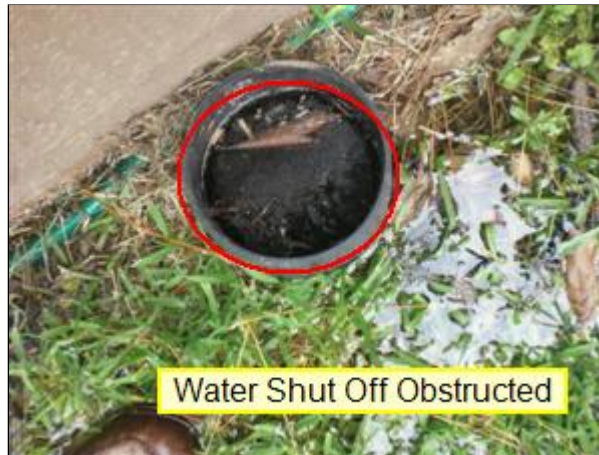
6.3

The water shut off valve is obstructed. This valve should be readily accessible in case of a plumbing emergency.

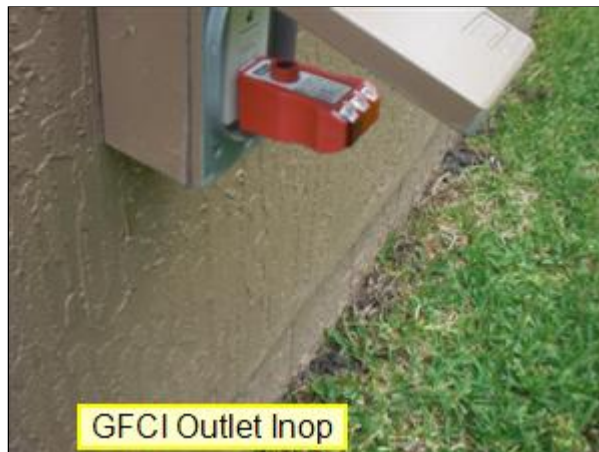
7.5

One GFCI (Ground Fault Circuit Interrupter) outlet at the back of the home did not work or there is no power to outlet. Electrical issues are considered a hazard until repaired. A qualified licensed electrical contractor should perform repairs that involve wiring.

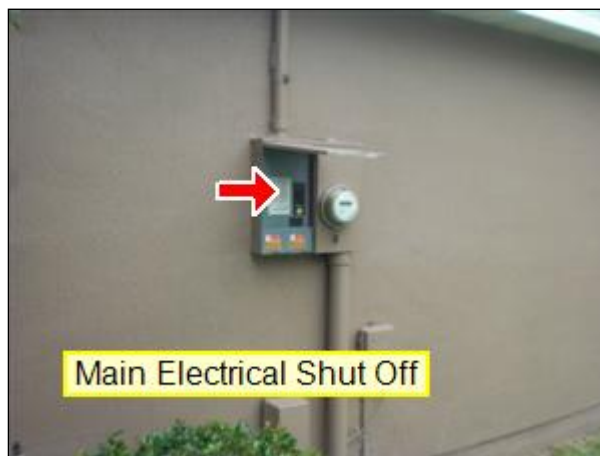
7.6

The main panel box is located at the garage. However, the main disconnect (shut-off) is outside at meter base panel (for your information).

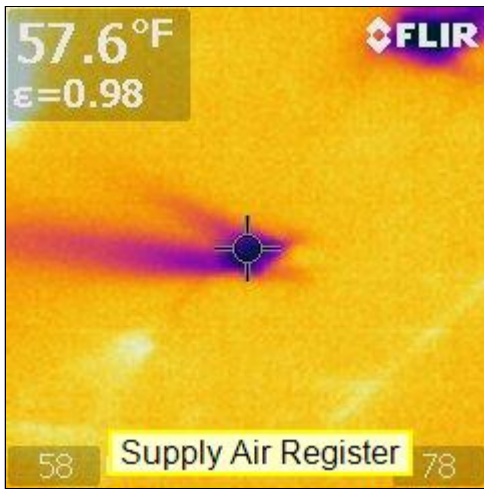
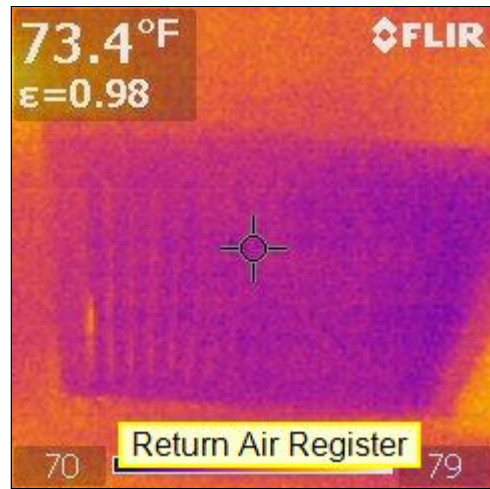
8.8

The ambient air test was performed by using thermometers on the air handler of Heat pump in cool mode to determine if the difference in temperatures of the supply and return air are between 14 degrees and 22 degrees which indicates that the unit is cooling as intended. The supply air temperature on your system read 57 degrees, and the return air temperature was 73 degrees. This indicates the range in temperature drop is normal.

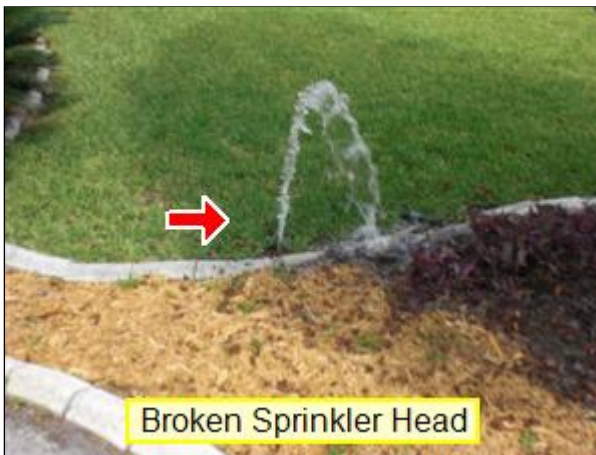
11.1

One of the heads is broken in zone 2. A qualified person should make repairs as required.
